GEOTECHNICAL STUDY AREA G15

ROBIN HOOD'S BAY, NORTH YORKSHIRE, UK

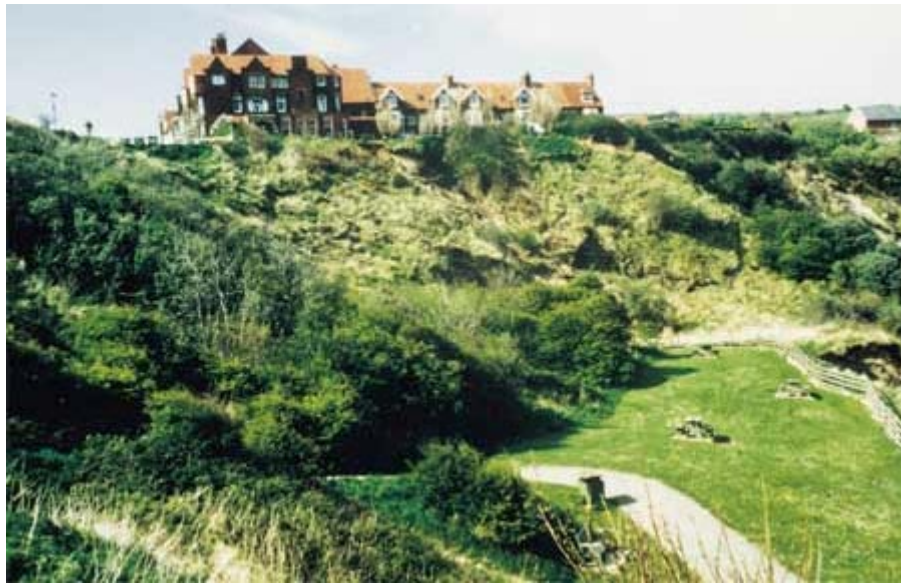
Plate G15a *Cliff top properties threatened by instability at Robin's Hood Bay*
